### PMC150/153/156/166 against rapid change in power

#### Important application note

Applied for: PMx150 / PMx153 / PMx156 / PMx166

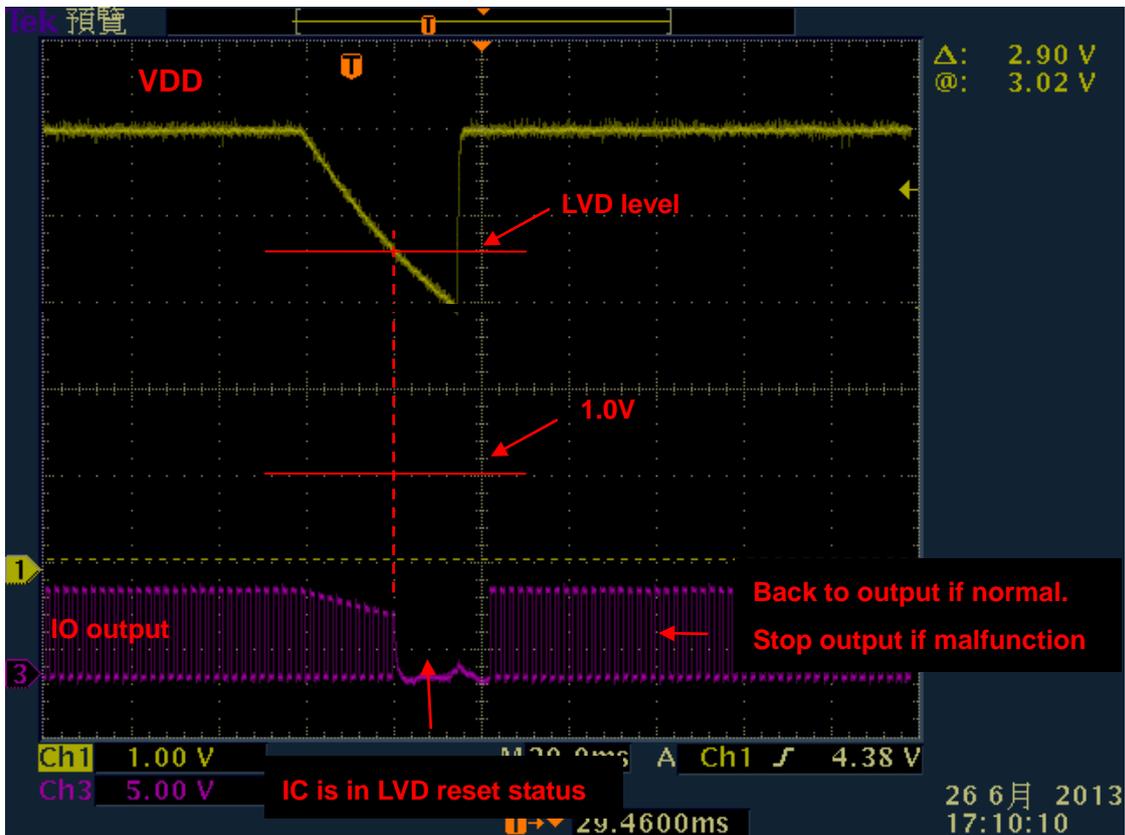
In some applications of PMC150/PMC153/PMC156/PMC166 series MCU, the power VDD may change rapidly because of quick switching the power source manually or strong power noise. In case, when the power VDD drops to the level that is lower than the LVD level but higher than 1.0V, if at this time the power VDD is pulled up again to be over LVD level (just see the diagram below), there may be some chances that cause the MCU malfunction or hanged.

To avoid the above problem, please follow the below steps in your program:

1. Insert the below two instructions just after the `.ADJUST_IC` instruction

```
SET1 inten.7
```

```
Intrq = 0;
```

- Never clear the **inten.7** through out the whole program. Please pay special attention in accidental clear **inten.7** by writing operation to the whole **inten** register. Please consider using **set1/set0** instruction to change other interrupt enable flags.
